DEPARTMENT OF TRANSPORTATION

Quality Assurance and Source Inspection

Contract #: 04-0120F4Cty: SF/ALA Rte: 80 PM: 13.2/13.9File #: 1.28**WELDING INSPECTION REPORT****Resident Engineer:** Casey, William**Address:** 333 Burma Road**City:** Oakland, CA 94607**Report No:** WIR-027934**Date Inspected:** 10-Jul-2012**Project Name:** SAS Superstructure**OSM Arrival Time:** 700**Prime Contractor:** American Bridge/Fluor Enterprises, a JV**OSM Departure Time:** 1830**Contractor:** American Bridge/Fluor Enterprises, a JV**Location:** Job Site**CWI Name:** Bernie Docena**CWI Present:** Yes No**Inspected CWI report:** Yes No N/A**Rod Oven in Use:** Yes No N/A**Electrode to specification:** Yes No N/A**Weld Procedures Followed:** Yes No N/A**Qualified Welders:** Yes No N/A**Verified Joint Fit-up:** Yes No N/A**Approved Drawings:** Yes No N/A**Approved WPS:** Yes No N/A**Delayed / Cancelled:** Yes No N/A**Bridge No:** 34-0006**Component:** SAS Tower**Summary of Items Observed:**

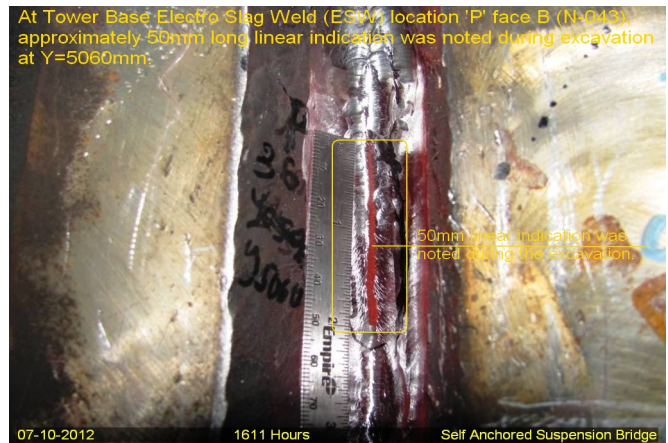
At Tower Base Electro Slag Weld (ESW), this QA observed ABF welder Jin Pei Wang perform repair excavation at location 'P' face B (N-043) Y=5060mm due to Ultrasonic Testing (UT) detected defect. The repair excavation is being undertaken per Caltrans approved Request for Weld Repair (RWR) #201206-074. The welder was noted using carbon air arc gouging followed by grinding using a die grinder. The following excavation events were noted during the repair excavation;

| ESW location | Y-dim | Depth of excavation | Noted defect |
|---|---|---|---|
| 3. 'P' (B) | 5060mm | 36mm | 50mm long linear indication. |
